Ground Related Risk to Transportation Infrastructure

**M3 Case Study - Impact of aggressive ground conditions
on corrugated steel highways drainage assets**

AECOM – Ground Engineering

26-27th October 2017

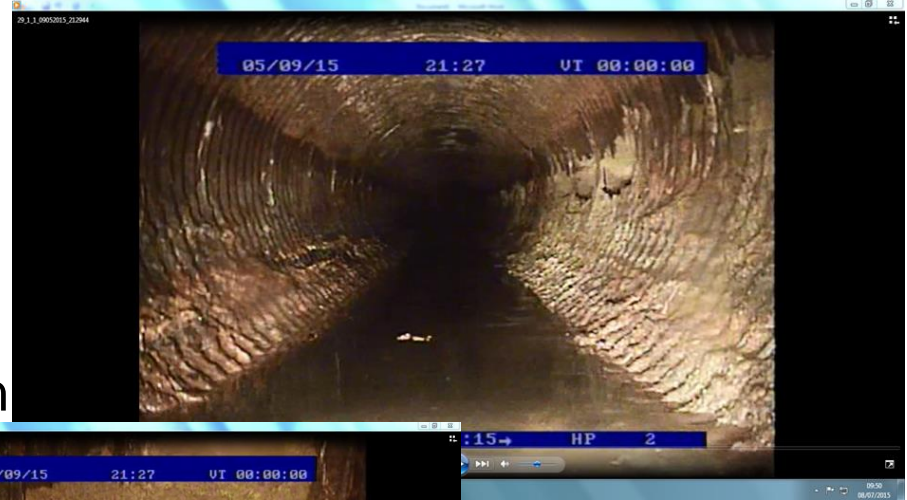
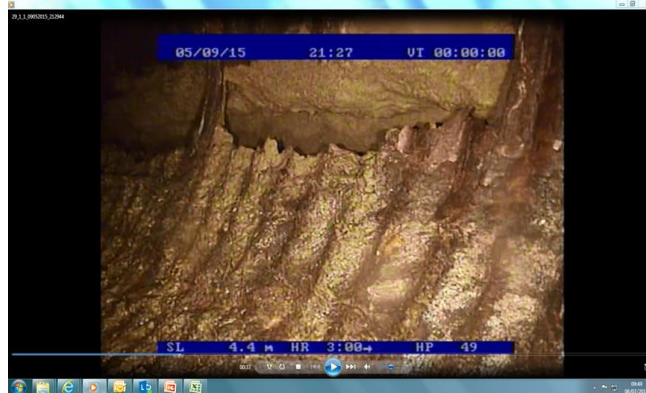
- Corroded especially at water line
- Silt and sand has migrated into the pipes where corroded
- Voids discovered adjacent to pipe associated with areas of corrosion

Conclusion: Ground at site very aggressive to steel

- Road salt
- Pipe age – potentially about 40 years

- Two large voids encountered under hardshoulder and immediately infilled. Pipe length replaced.
- Small voids infilled with concrete
- Confidence that treatment of carrier pipe in-situ was adequate solution for majority of 4.5km

Corrugated steel pipe left in place as former for remedial lining

Remedial liner consisted of a UV-cured Polyester Resin sock

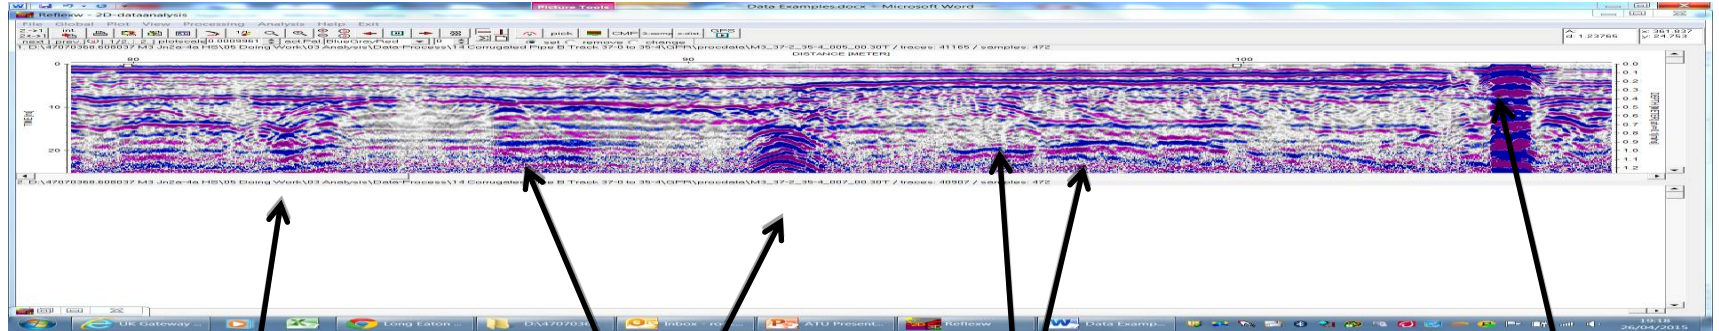
Ground Penetrating Radar (GPR): A typical 2D GPR profile

Construction
change / possible
service or void

Possible
service or
void

Striations

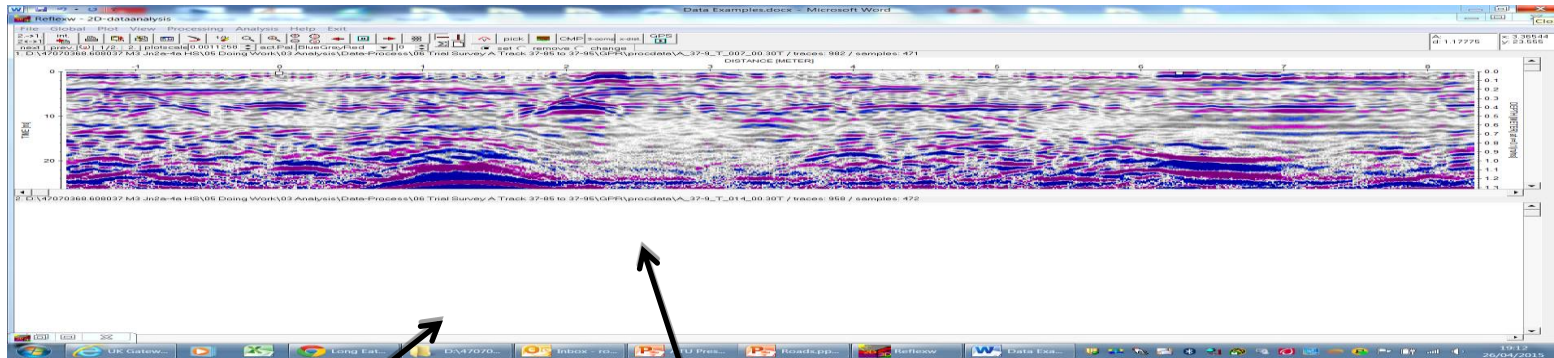
Ground Penetrating Radar (GPR): Carrier pipe in good condition

Carrier pipe

Concrete backfill /
possible saturated
materials
