Geological Society – Hong Kong Regional Group
Advances in Terrain Mapping for
Landslide Hazard Assessment

Evolution of Natural Terrain
Hazard Assessment Strategy in Hong Kong

K.C. Ng, H.Y. Ho & K.J. Roberts

Geotechnical Engineering Office
Civil Engineering and Development Department
Hong Kong SAR Government

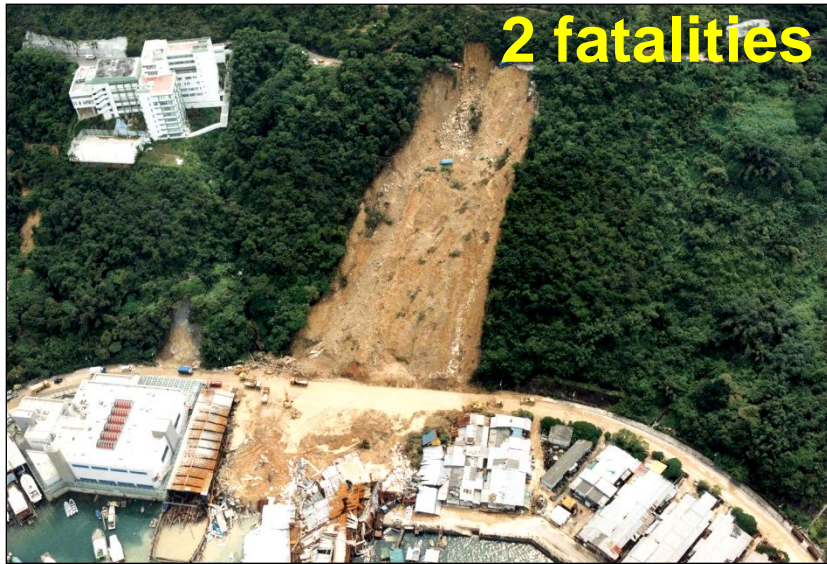
1995 Shum Wan Rd Landslide (26,000 m³)

2 fatalities

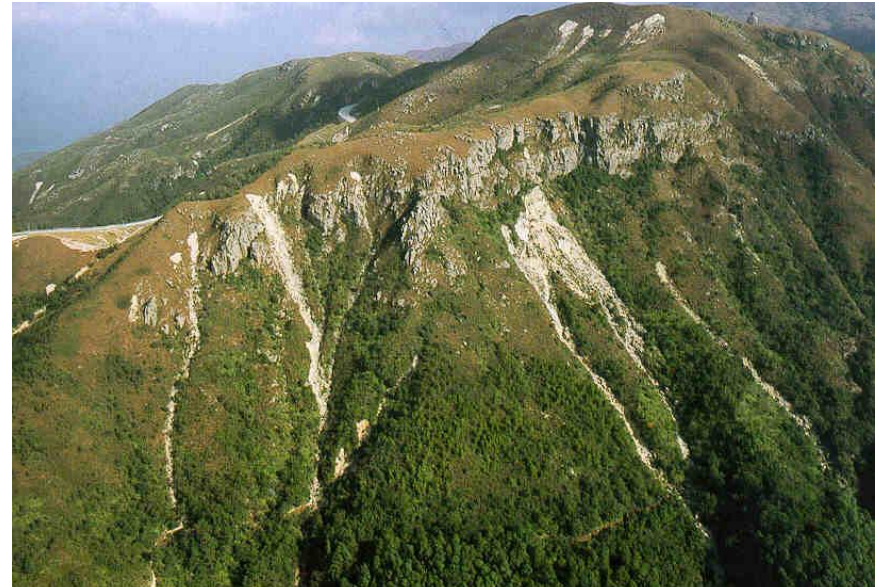
1990 Tsing Shan
Debris Flow

Source volume
 350 m^3

Valley
colluvium
(bouldery)

- Runout distance 1 km^2
- Travel angle $23^\circ - 24^\circ$

Debris volume
 $20,000 \text{ m}^3$

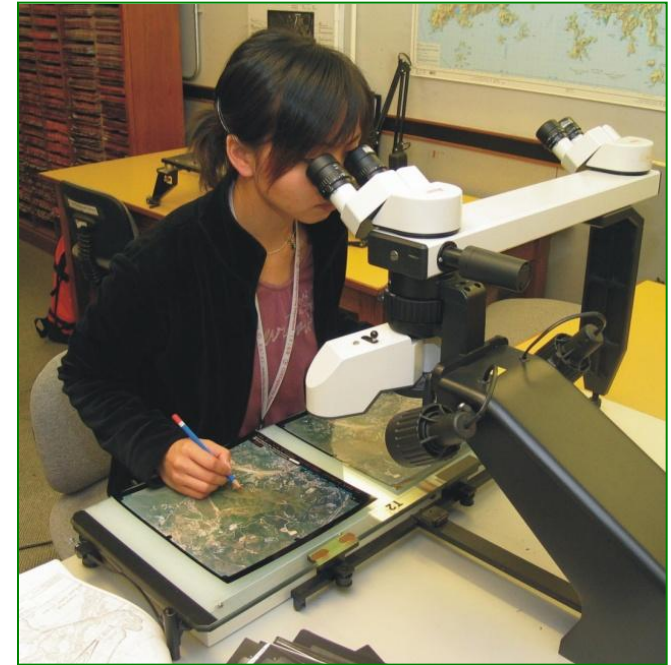
Scoping Programme – Natural Terrain Landslide Study

- Natural Terrain Landslide Inventory (1995)
- Large Landslide Dataset (1998)
- Natural Terrain Susceptibility Analysis (1998)

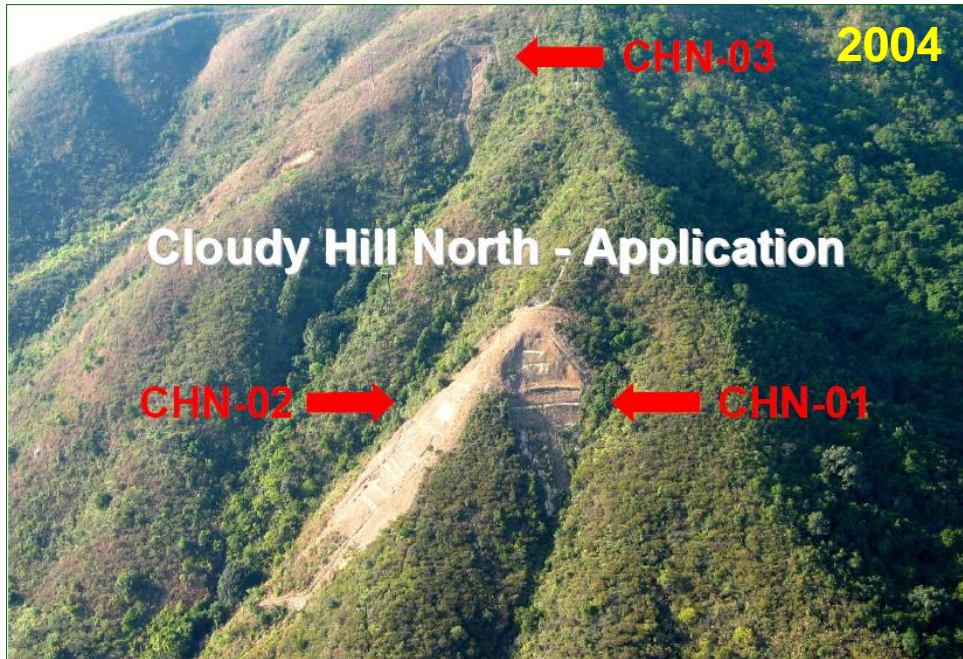
Soil Bioengineering

- Live cut branches &/or rooted woody plant materials
- Native vegetation around installation areas
- Specifically select & arrange to assist in controlling: shallow mass movement, water collection & transport, and surface erosion

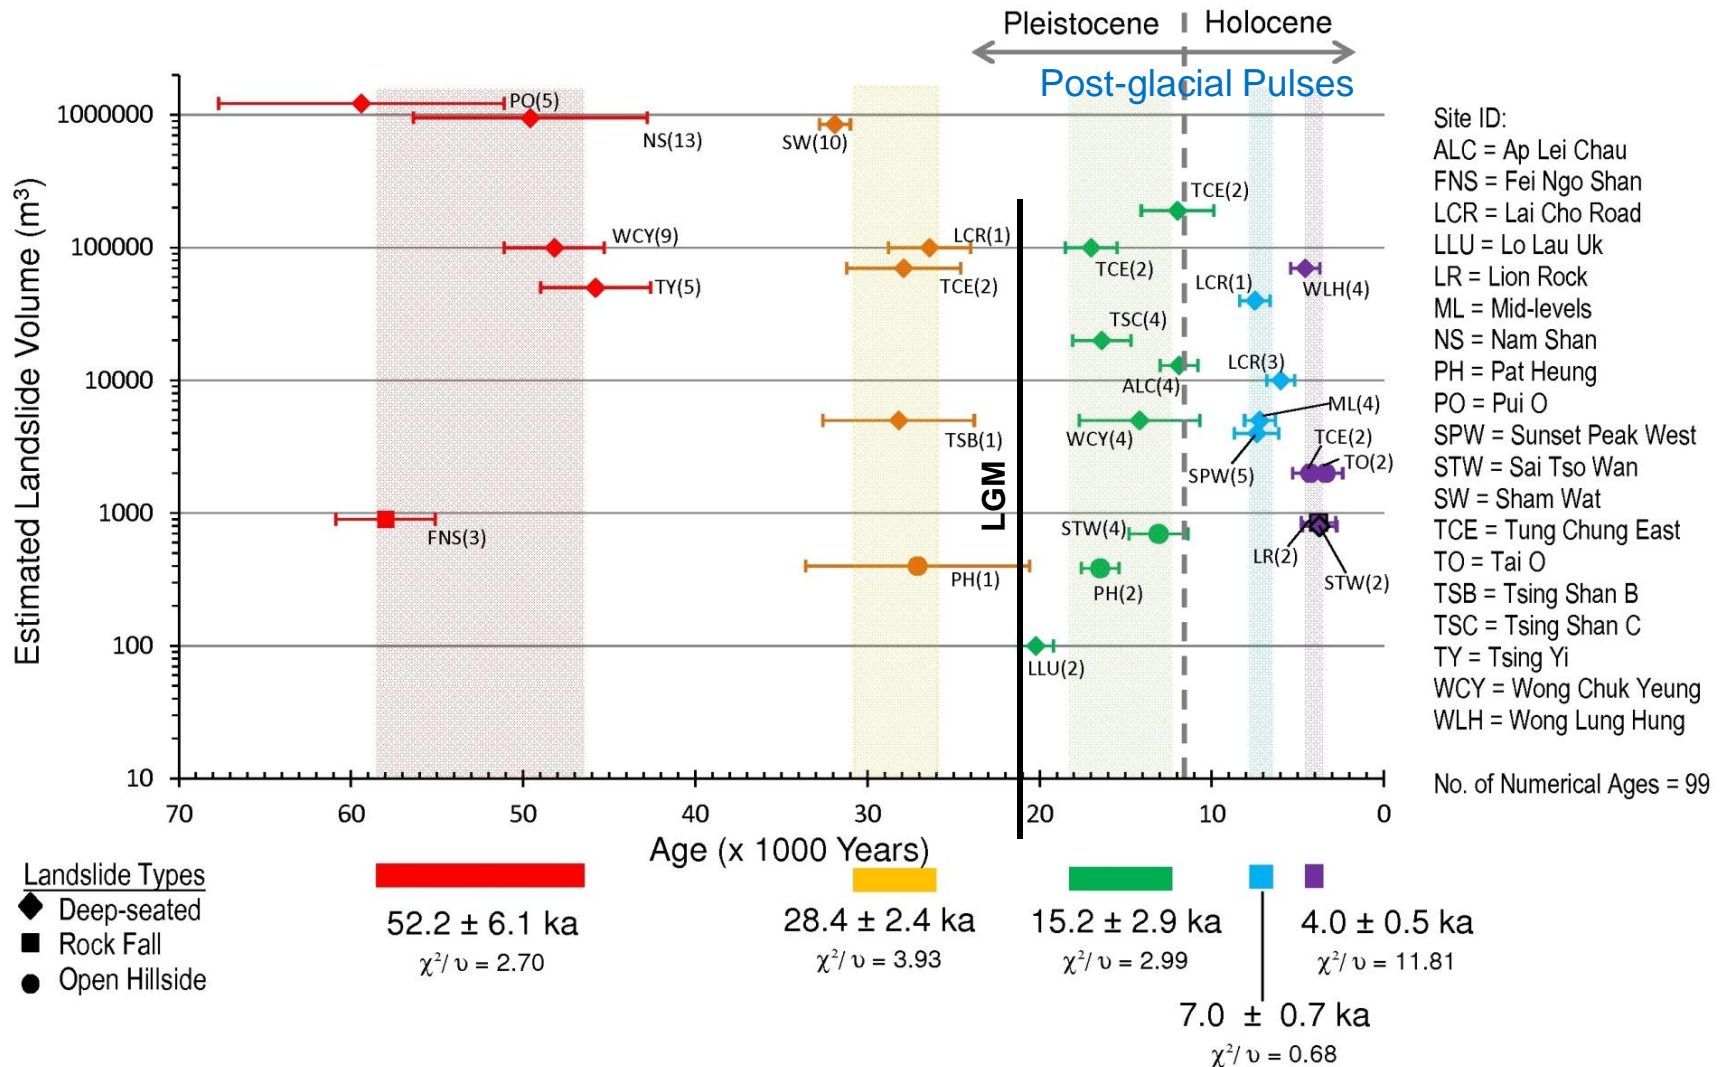
Landslide Age/Volume Relationships of Large Landslides and Rockfalls (OSL & Cosmogenic Nuclide methods)

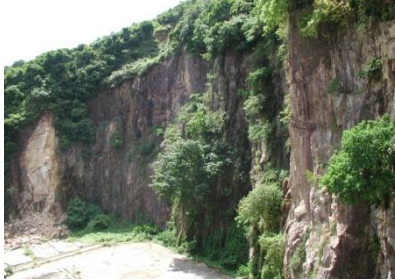
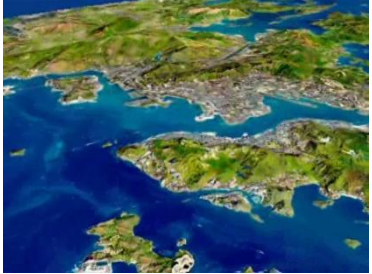
Position Data (Status)	Terrestrial	Air-borne	Space-borne (satellite)
Image (Photogrammetry) (Routine)

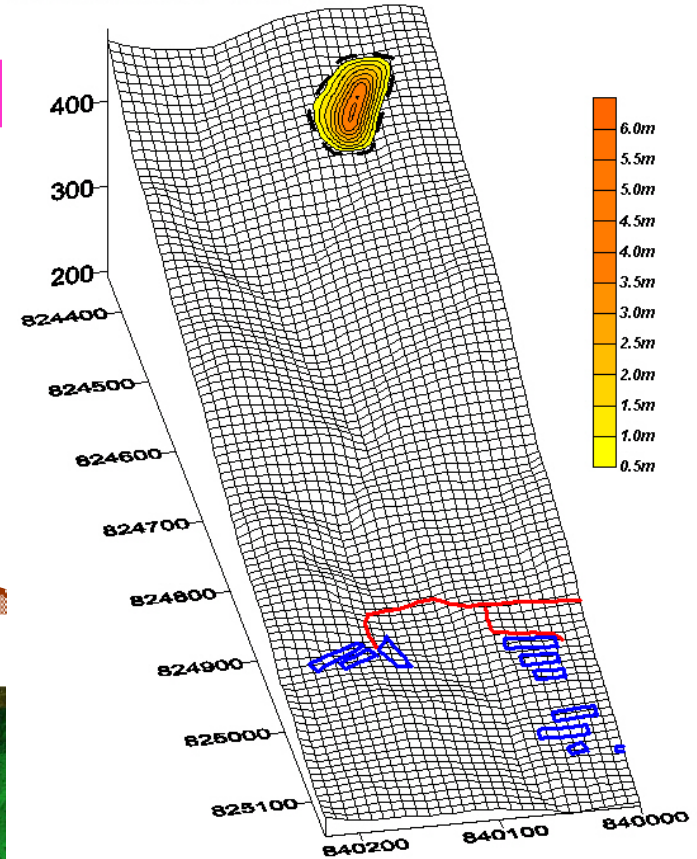
Kwun Yam Shan Time=0.0s

Digital Elevation Model –
Debris Mobility Modeling

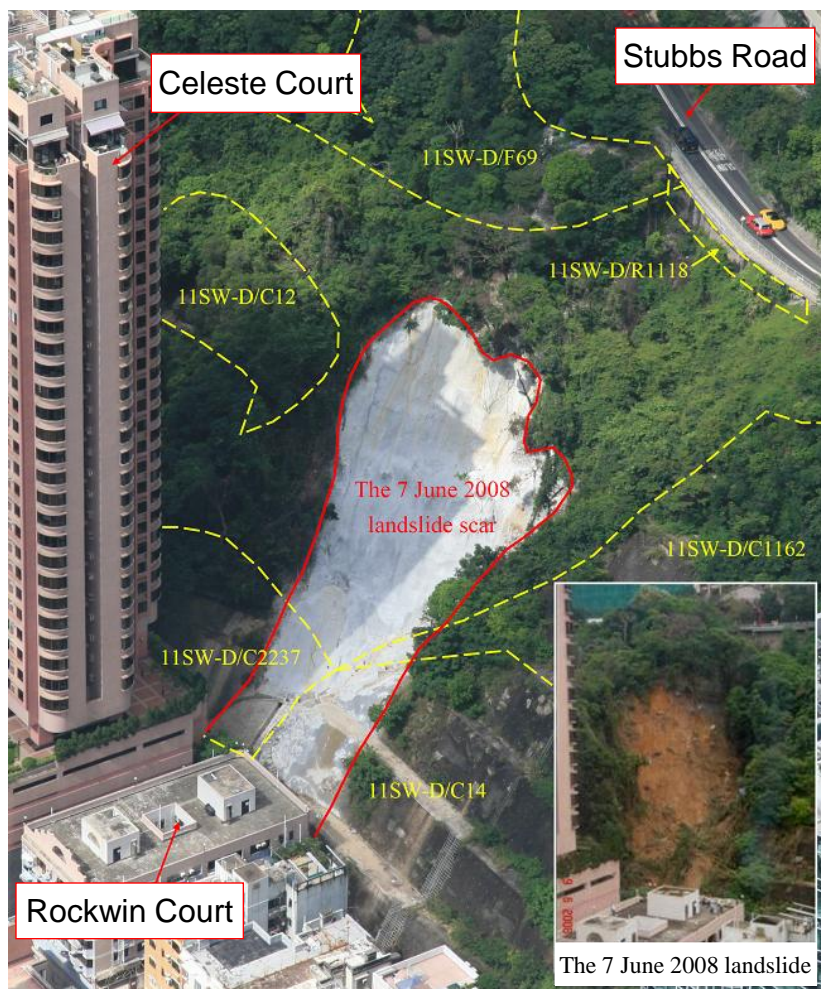
Potentially Problematic Hillside Pockets

small tracts of hillsides flanking developed areas

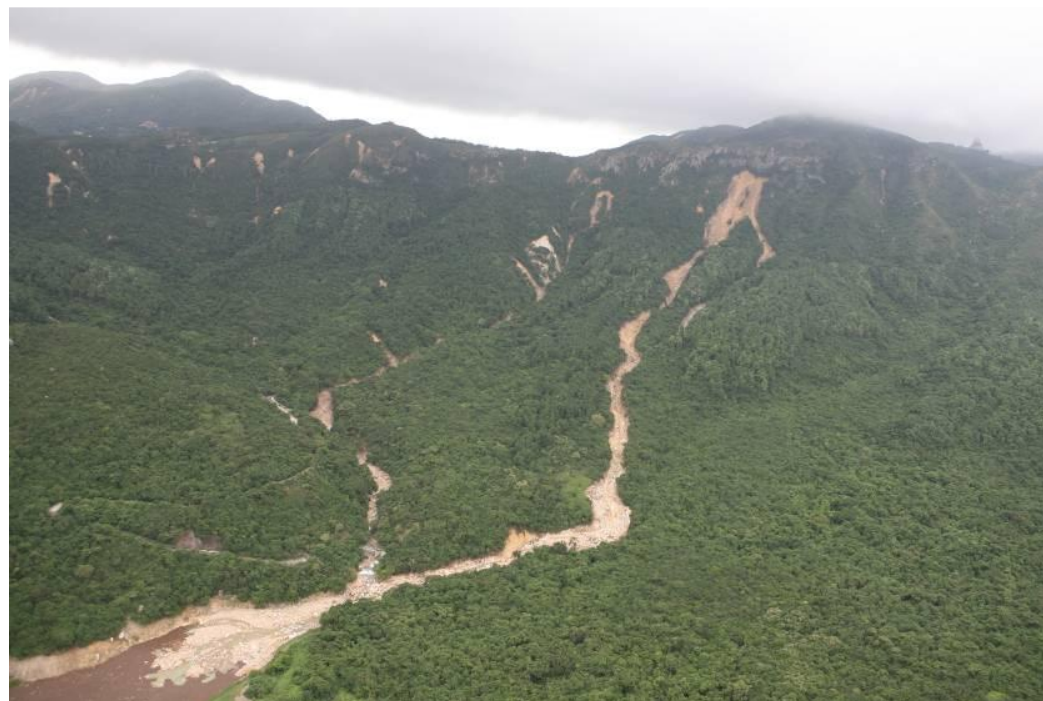
Sizeable Catchments with Major Drainage Lines

potential locations of low-frequency, large-magnitude debris flows affecting high consequence facilities
