Ground Related Risk to Transportation Infrastructure

**M3 Case Study - Impact of aggressive ground conditions
on corrugated steel highways drainage assets**

AECOM – Ground Engineering

26-27th October 2017

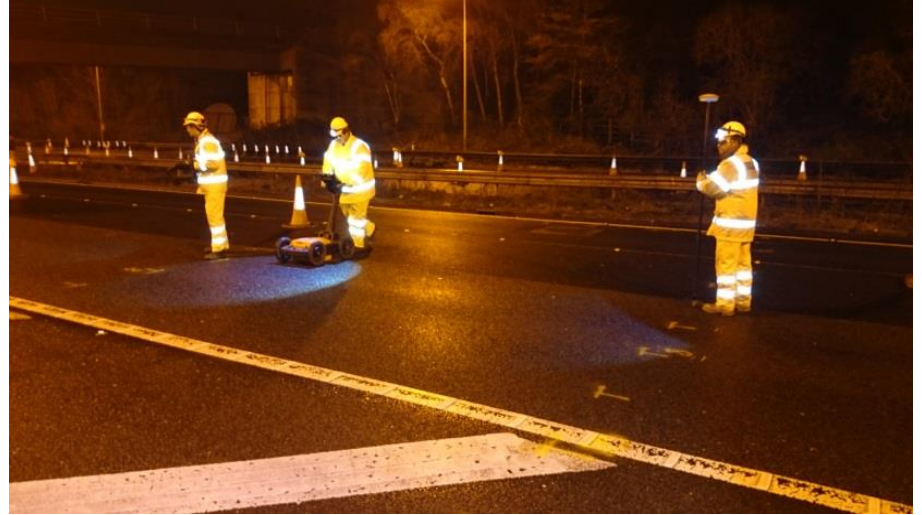
- Location of the corrugated steel pipes mapped from historical data and CCTV surveys
- GPR surveys undertaken by AECOM's geophysics staff
- Due to live motorway survey work primarily undertaken at night
